Manhole Inspection Summary

Manhole # S17K__052MH

Insp Date: **3/10/09 2:02 PM**

Location Address: **2324 FREDERICK AVE**

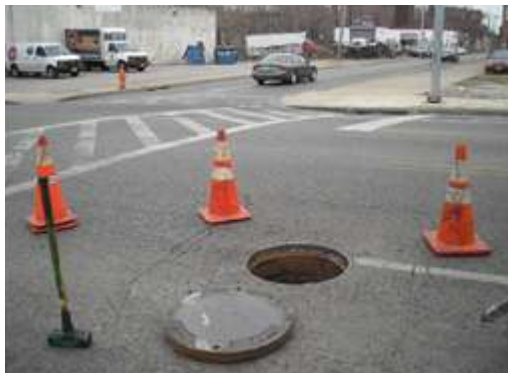
Location View

looking towards northbound warwick ave

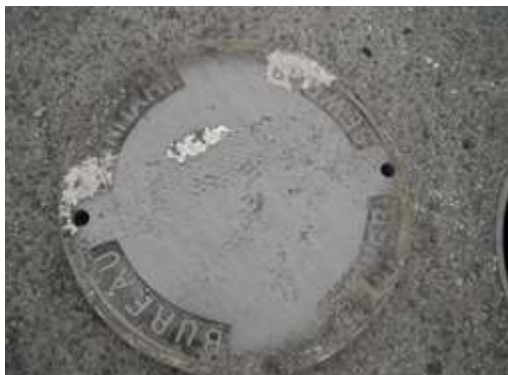
Miscellaneous

Type: **Sanitary** Condition: **Worn** Cover Material: **Cast Iron**

worn 24" sanitary cover

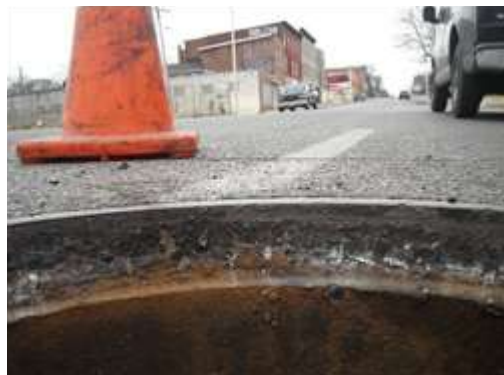
Miscellaneous

evidence of infiltration due to sheeting from roadway drainage

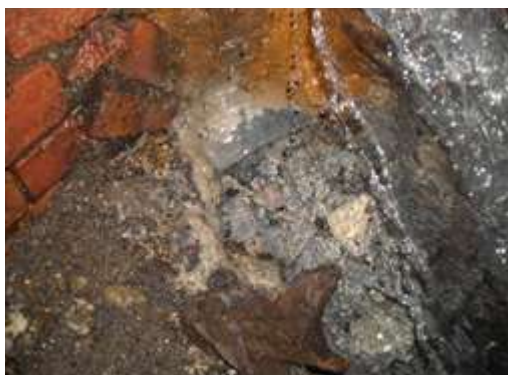
Miscellaneous

possible drop extension @ 7 oclock seems capped - but it may be solid debris

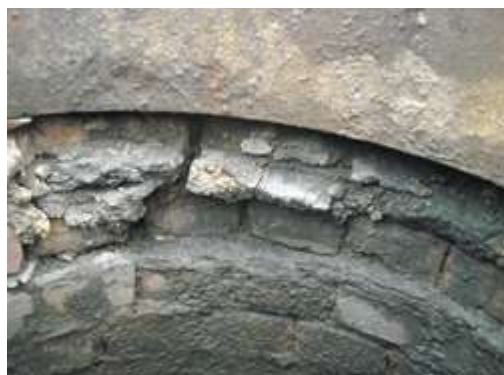
Defect 4

Chimney / Frame Adjustment ☒ Exists Material: **Brick and Concrete** ☒ Parged Height: **7** (in.)

Condition: ☐ Sound ☐ Cracked ☐ Root Intrusion ☒ Loose Brick ☒ Deteriorated

chimney adjustment 7" has loose bricks & is deteriorated

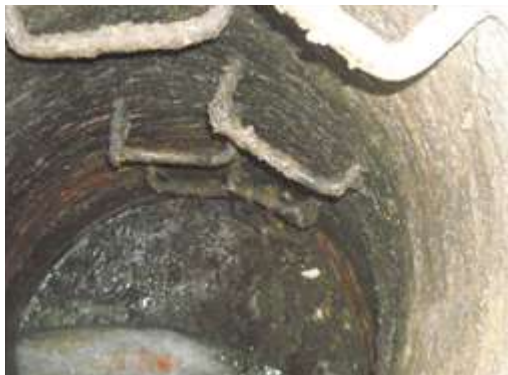
Defect 2

Surcharge ☒ Evidence Of Surcharge Depth: **8** (ft.) ☐ Active Surcharge Present

evidence of prior full surcharge - feces
and other evidence on steps observed
during man entry

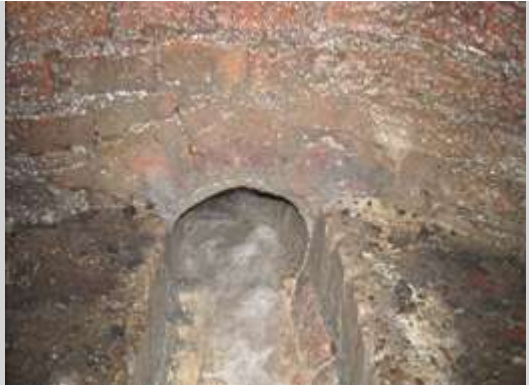
12 O'Clock Outflow

Pipe Height: **9.6** (in.) Rod and Bar (Angled)
Pipe Material: **Clay** ☐ Pipe Lined
Invert Depth: **13.39** (ft.) Flow Characteristics: **Fast**
Deposits: ☒ None ☐ Mud ☐ Sludge ☐ Debris ☐ Grease
Silt Depth: **0** (in.) Deposits Extent:
Infiltration: **None** Pipe Seal Cond: **Sound**

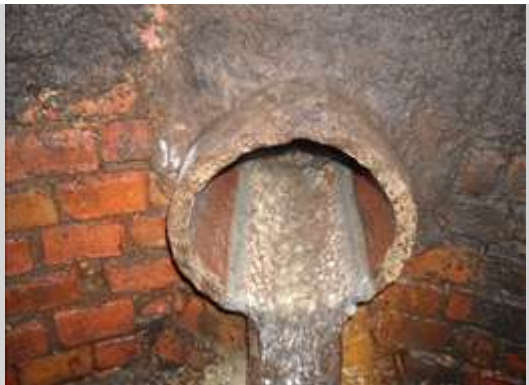
7 O'Clock Inflow

Pipe Height: **8.4** (in.) Rod and Bar (Angled)
Pipe Material: **Clay** ☐ Pipe Lined
Invert Depth: **11.72** (ft.) Flow Characteristics: **Fast**
Deposits: ☒ None ☐ Mud ☐ Sludge ☐ Debris ☐ Grease
Silt Depth: **0** (in.) Deposits Extent:
Infiltration: **None** Pipe Seal Cond: **Sound**
